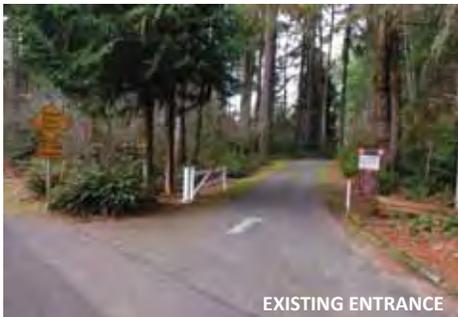
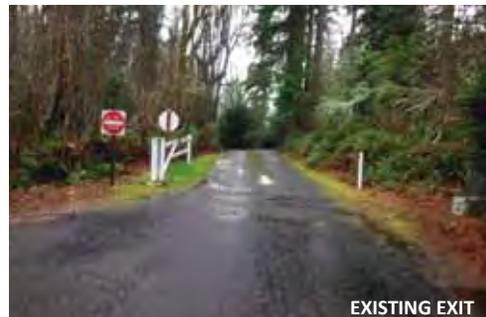
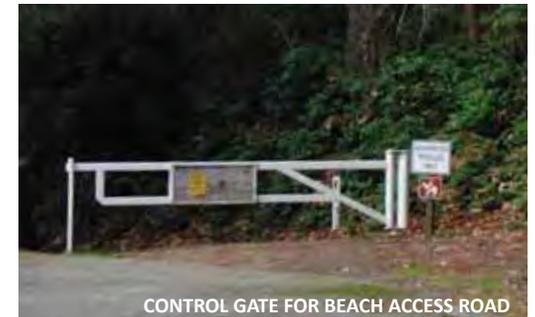
Vehicle and pedestrian access from the parking lot to the beach is via a gravel road. Access is controlled by the ranger through a manually operated and lockable gate at the north end of the main parking lot. The gravel surfacing is in relatively good condition and does not exhibit any significant erosion of the travelled surface itself. This road is used by service trucks (for beach area restroom and maintenance), park visitors (limited mostly to interpretive class leaders and car-top boat launching), and fire/sheriff vehicles. The fire department has expressed concern over the lack of a proper turnaround at the bottom of the access road.

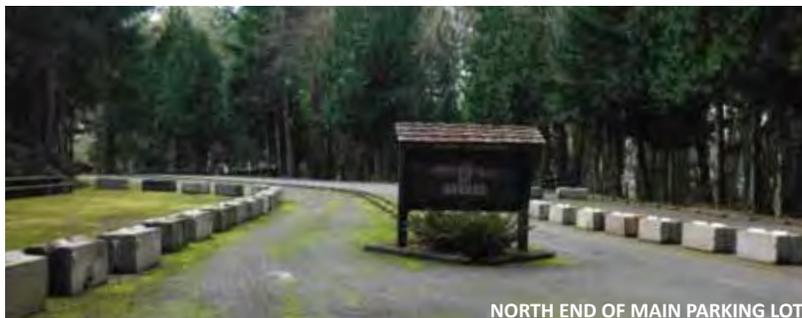
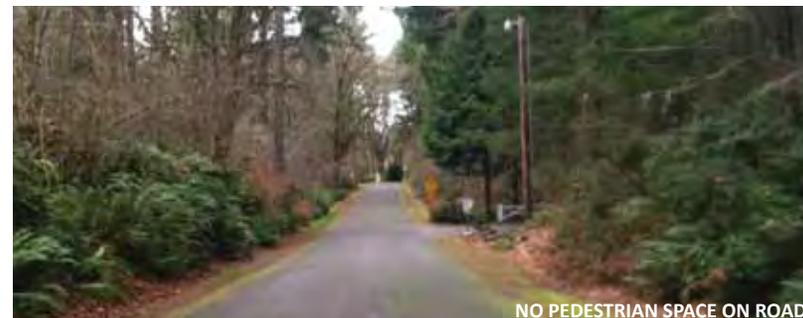
Because of the risk of falling trees, the existing main parking lot has been reduced in size to a total of 150 stalls. The current parking lot, while set up for 90° parking, is less than the current standards for width. The current configuration is 116' for two double-loaded 90° bays; however, the standard for the same configuration is 130' with a 2' separation between bays. The parking lot is paved with asphalt and is in relatively poor condition. There are obvious signs of significant pavement and asphalt curb failure, erosion problems at the perimeter, and moss growth.

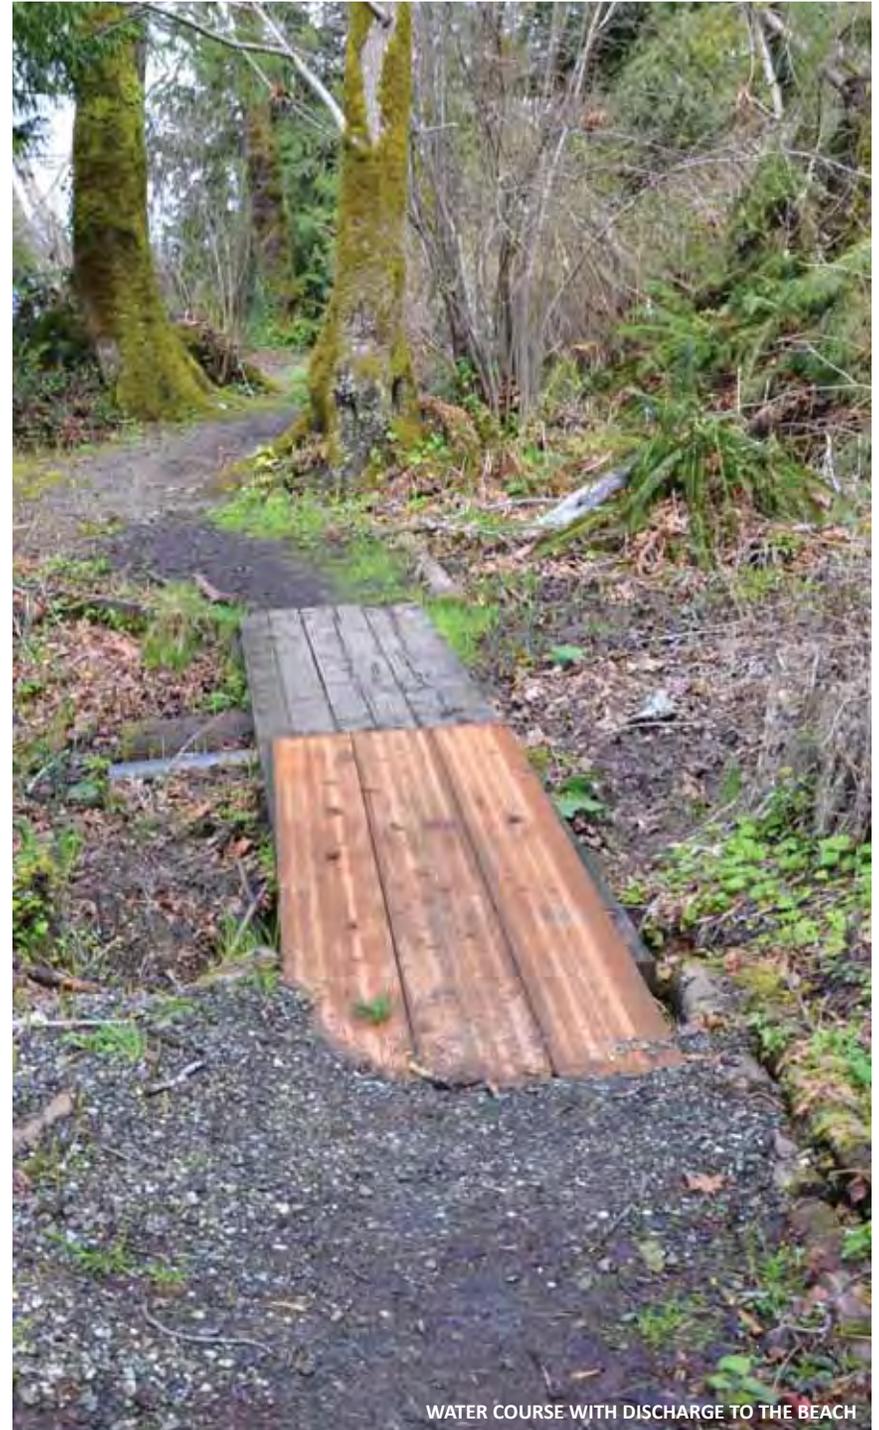
WATER COURSE WITH DISCHARGE TO THE BEACH

The existing gravel access road from the parking lot down to the beach area does not have a formal collection/conveyance system. However, the gravel surfacing is in relatively good condition and does not exhibit any significant erosion on the travelled surface itself. There is a shallow ditch on the north side of the road which collects and conveys groundwater to the base of the slope where it is released in an open stream and eventually leads down to the beach.

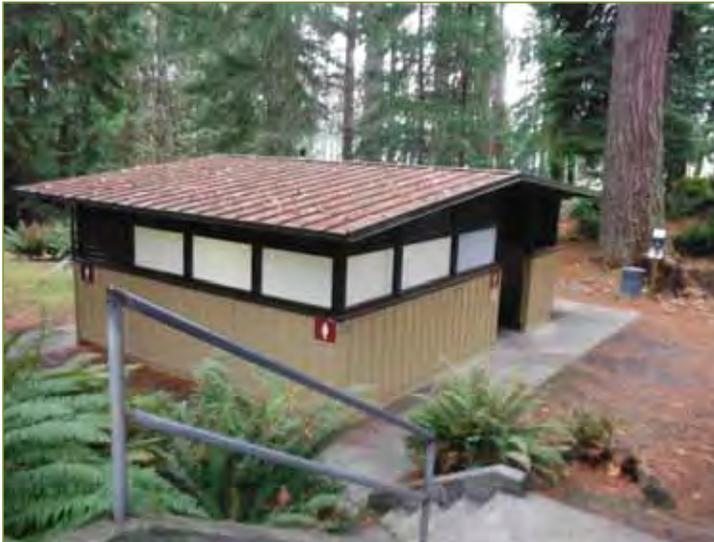
DAY USE AREA

This building, constructed in 1959, does not meet current ADA requirements. In particular, deficiencies include:

- no accessible route to the building
- significant grade differences between the restroom and parking area
- clearance around the toilet does not meet the 60" x 56" minimum
- grab bars are not properly located
- toilet centerline is too close to the side wall
- the exterior approach to the restroom door is too narrow
- toilet accessories – mirrors and soap/paper towel dispensers – do not meet ADA mounting heights

The building and fixtures do not comply with current energy standards. To remedy these deficiencies, the building would need to be enlarged. Modifying the existing structure and access routes to comply with current codes would be more expensive than demolition and replacement. That fact, coupled with the age of the restroom itself, makes remodeling the restroom untenable.

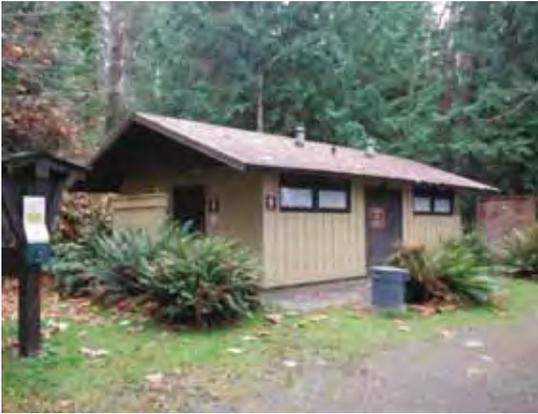
BEACH

In addition to the same ADA deficiencies noted for the day use area restroom, this restroom, constructed in 1972, also shows non-repairable settling and considerable wood deterioration along the base of the walls. Due to these deficiencies and deteriorated sewer line conditions, State Parks staff should remove the building in order to protect public safety and water quality.

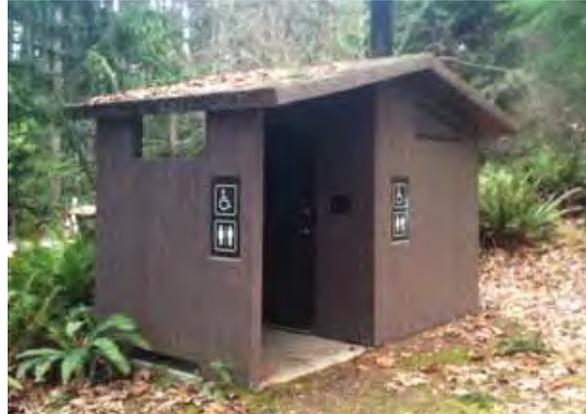
GROUP CAMP

This building is a precast concrete vault toilet structure. Due to the potential risk of falling trees, this restroom is also closed and it is unlikely that it will be used in the future so long as the risk of falling trees remains. Previous research by Parks staff indicated that the building cannot be reused to replace the beach restroom because of turning radii difficulties for a truck sufficiently large enough to haul the building in one piece as it cannot be disassembled. The restroom has been used as a back-up when the day use restroom was shut down for repairs.

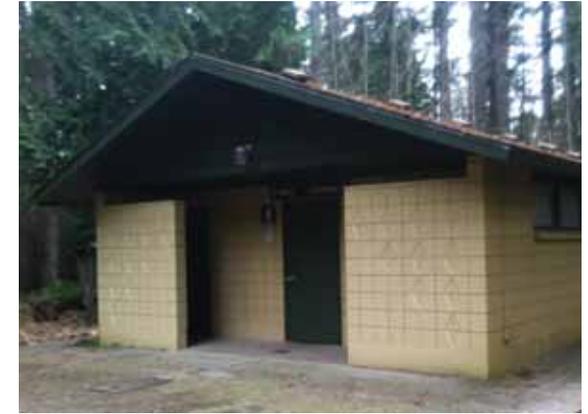
CAMPGROUND

This building, constructed in 1967, is currently closed and is intended to remain closed because of the risk of falling trees due to laminated root rot. Because of that risk and because it is unlikely that trees will be removed in sufficient number and distance to protect the building, the building should be removed as it does not meet ADA requirements and will continue to deteriorate over time.

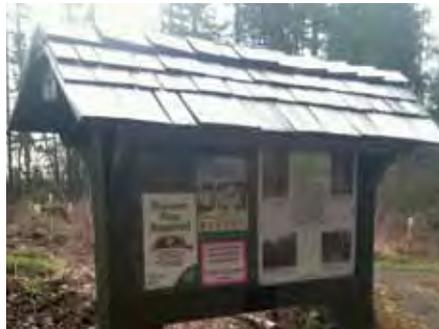
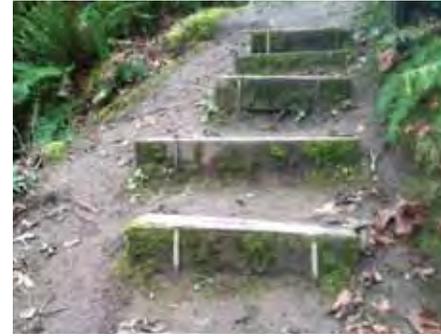
BEACH LOOP

The beach loop trail provides access from the day use parking lot and picnic area directly to the beach. Virtually all of the soil is poor draining and subject to erosion. Over the years, attempts to arrest the erosion and provide access in steep areas have resulted in a variety of materials and solutions throughout the length of the trail. A small bridge has an unsafe base and portions of the trail close to the beach are constantly shifting. Social trails that have evolved pose risks to visitors because of their precarious locations and conditions resulting from lack of maintenance.
