Issaquah Creek Footbridge

Issaquah Creek Streambank Enhancement, Creek Play Area

Issaquah Creek Streambank Enhancement

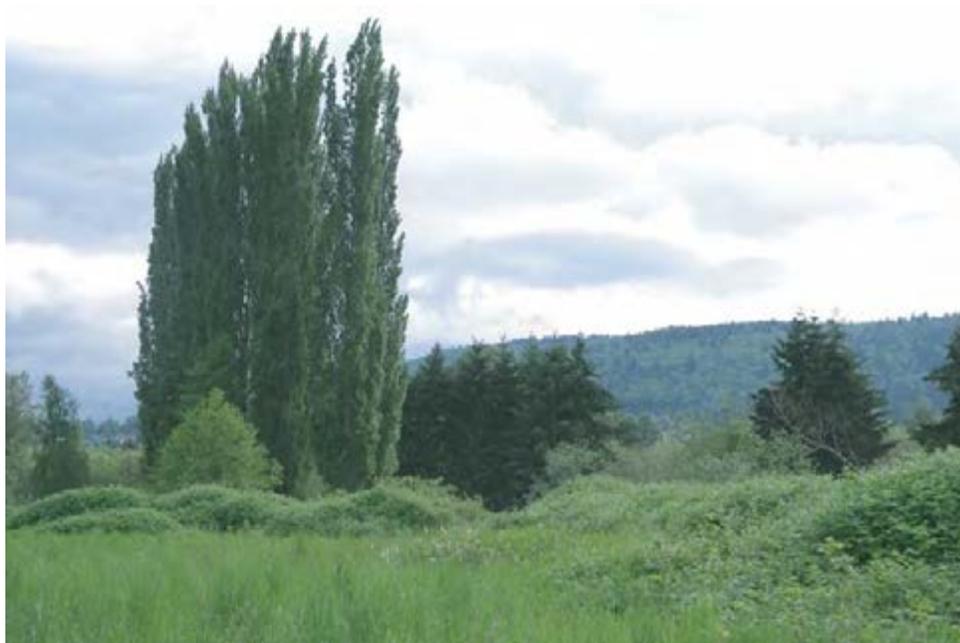
Centrally-located along the portion of Issaquah Creek on-site is a relatively straight and narrow channel section confined by dense blackberry thickets on both sides. This section, unlike the channel sections immediately upstream and downstream of it, shows little recent tendency to migrate and has relatively little bank erosion.

As such, it is likely that the best location for an additional footbridge crossing of Issaquah Creek would occur somewhere along this section. One area of interest is just downstream of a row of existing poplar trees. This location is fairly close to either alternative for a “creek play” area (projects C1 and C2), and is an opportunity for a relatively short-span bridge due to a fairly deep, stable stream channel with steep sides.

Possible site for an additional footbridge

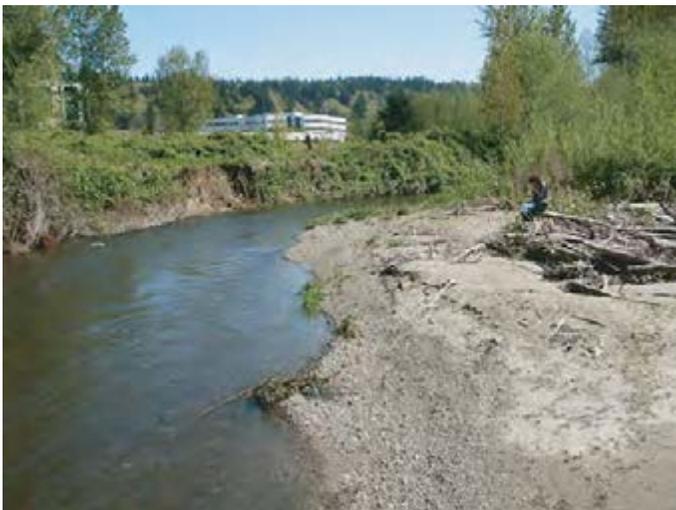
Along the right streambank at the eastern park boundary is a vertical, eroding streambank 10-12 feet high and approximately 150 feet long. The area is grassy with little vegetation extending landward from the top-of-slope. The eroding, migrating streambank is encroaching upon a section of trail.

Existing streambank and gravel bar offer potential for recreational usage

- 1) re-sloping the vertical bank to a slope of 2:1, H:V or flatter
- 2) placing numerous logs, possibly in the form of a root wad revetment, to stabilize the toe of the slope and provide fish and wildlife habitat functions
- 3) removing non-native vegetation around the periphery (blackberries) not eliminated by grading
- 4) revegetating with native plant species

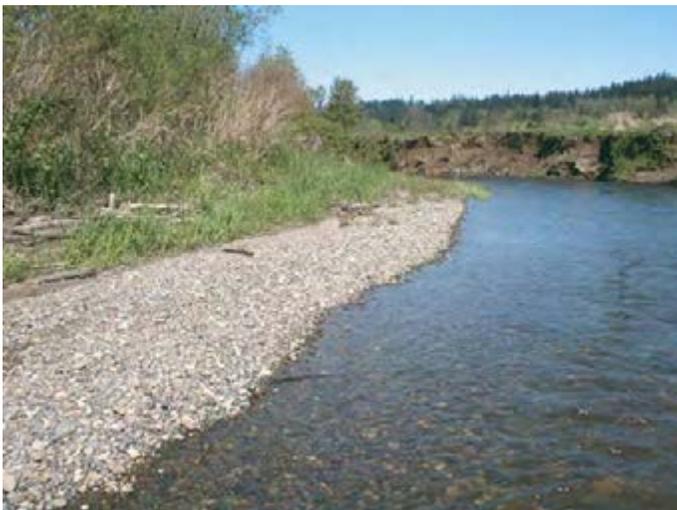
Along the right streambank in view of business park buildings near the eastern park boundary is a vertical, eroding streambank 10-12 feet high and approximately 150 feet long. The area is grassy with little vegetation extending landward from the top-of-slope. The eroding, migrating streambank is encroaching upon a section of trail.

Existing gravel bar provides recreational opportunities

- 1) re-sloping the vertical bank to a slope of 2:1, H:V or flatter
- 2) placing numerous logs, possibly in the form of a root wad revetment, to stabilize the toe of the slope and provide fish and wildlife habitat functions
- 3) removing non-native vegetation around the periphery (blackberries) not eliminated by grading
- 4) revegetating with native plant species

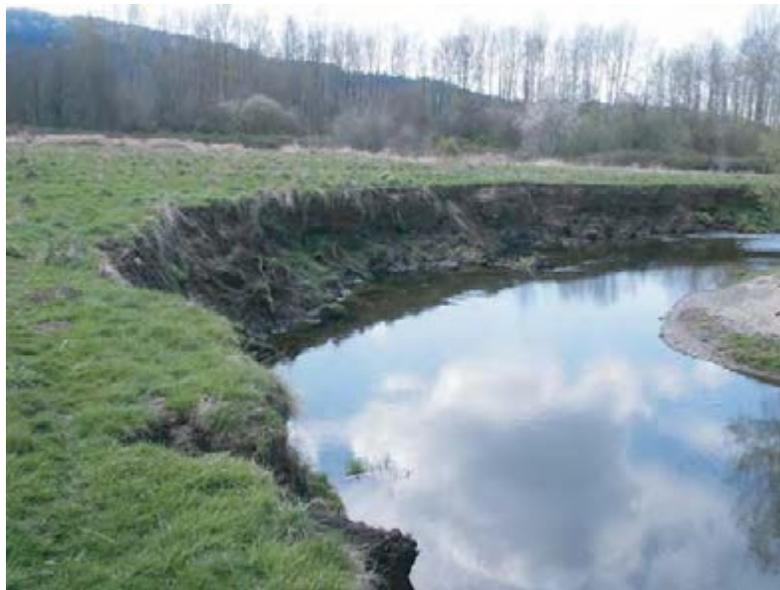
Along the left streambank just upstream of a prominent oxbow is a vertical, eroding streambank 10-12 feet high and approximately 300 feet long. The area is grassy with little vegetation extending landward from the top-of-slope. The eroding, migrating streambank has made it necessary to relocate a section of trail farther from the creek for safety reasons.

The migrating streambank

- 1) re-sloping the vertical bank to a slope of 2:1, H:V or flatter
- 2) placing numerous logs, possibly in the form of a root wad revetment, to stabilize the toe of the slope and provide fish and wildlife habitat functions
- 3) removing non-native vegetation around the periphery (blackberries) not eliminated by grading
- 4) revegetating with native plant species.

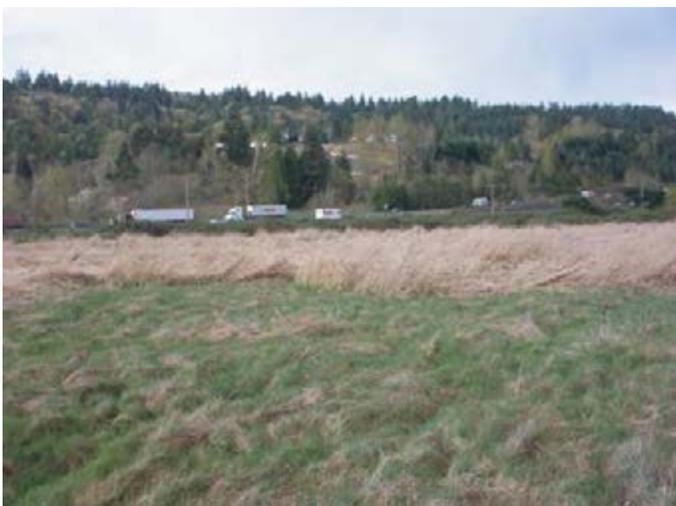
The Greenwood property is approximately 14.8 acres, extending from Interstate 90 across the lower reaches of Tibbetts Creek, including the mouth of the creek at Lake Sammamish. This property, which is proposed for future acquisition by Washington State Parks, includes approximately 12 acres of abandoned pasture and hayfield. This large open field is primarily dominated by reed canarygrass surrounded by blackberry thickets with some trees along the edges. Schneider Creek flows from a culvert under the freeway along the western margin of the property to Lake Sammamish. The lakeshore is well vegetated with dense and diverse trees, shrubs, and emergent vegetation. There is abundant downed wood and complex habitat structure.

The abandoned hayfield along Interstate 90

This property provides a tremendous opportunity to greatly improve fish and wildlife habitat, as well as aesthetics. Schneider Creek could be relocated to the east with a meandering stream channel, associated backwater depressions, log structures, and revegetation with a diverse assemblage of native riparian and wetland plants. Other wetland depressions created throughout the field could further increase the complexity and

edge character of the habitat while altering microclimates to discourage invasive plants. Installation of snags and brush piles, comprehensive and diverse revegetation, and screening with trees planted along the freeway all would contribute to the overall restoration and value of this area. A trail from the baseball fields and parking lot could lead to an overlook and/or boardwalk through the restored wetland with interpretive signage.

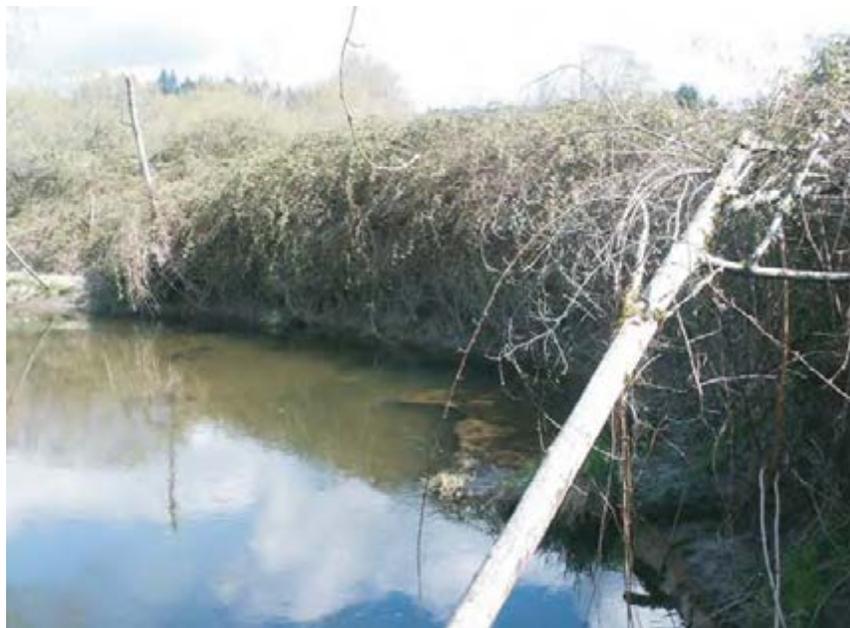
Along the left streambank just upstream of the "orchard" is a vertical, eroding streambank 8-10 feet high and approximately 120 feet long. The vegetation extending landward from the top-of-slope is primarily reed canarygrass and Himalayan blackberry.

Invasive species on existing streambank

- 1) re-sloping the vertical bank to a slope of 2:1, H:V or flatter
- 2) placing numerous logs, possibly in the form of a root wad revetment, to stabilize the toe of the slope and provide fish and wildlife habitat functions
- 3) removing non-native vegetation around the periphery (blackberries) not eliminated by grading
- 4) revegetating with native plant species

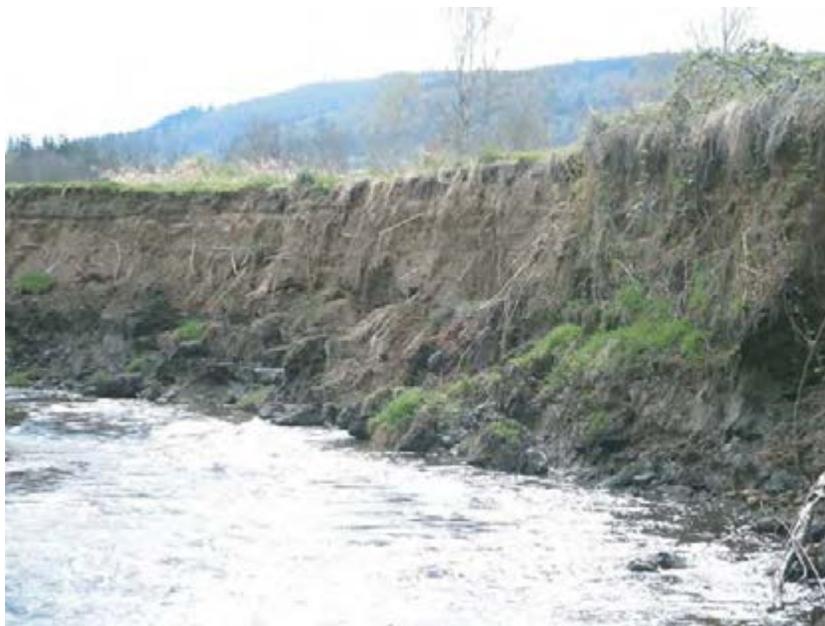
Along the left streambank just upstream of a more stable section, including a possible bridge crossing location, is a vertical, eroding streambank 10-12 feet high and approximately 150 feet long. The area is grassy with little vegetation extending landward from the top-of-slope. The eroding, migrating streambank has made it necessary to relocate a section of trail farther from the creek for safety reasons.

The eroding streambank

- 1) re-sloping the vertical bank to a slope of 2:1, H:V or flatter
- 2) placing numerous logs, possibly in the form of a root wad revetment, to stabilize the toe of the slope and provide fish and wildlife habitat functions
- 3) removing non-native vegetation around the periphery (blackberries) not eliminated by grading
- 4) revegetating with native plant species

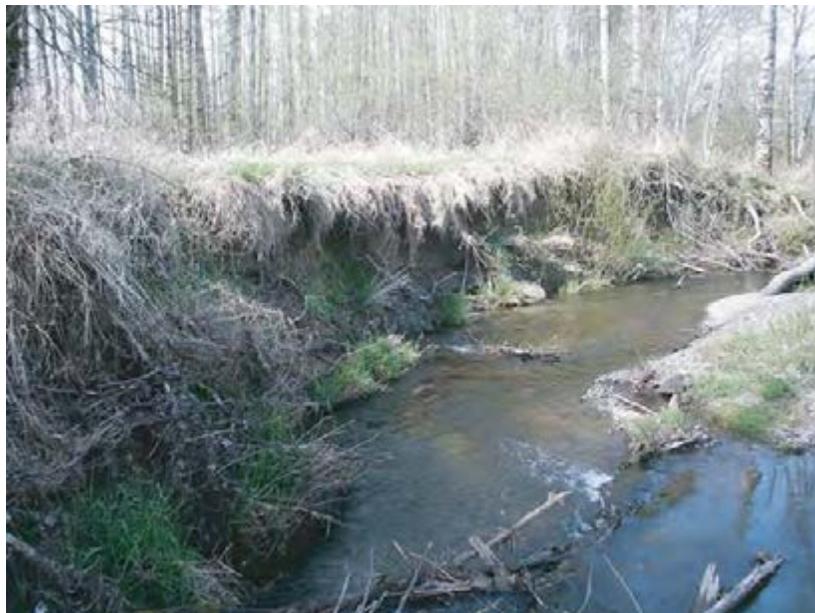
Along the left streambank just downstream of the "orchard" is a vertical, eroding streambank 10-12 feet high and approximately 75 feet long. The vegetation extending landward from the top-of-slope is primarily reed canarygrass and Himalayan blackberry.

Streambank encroached by invasive species

- 1) re-sloping the vertical bank to a slope of 2:1, H:V or flatter
- 2) placing numerous logs, possibly in the form of a root wad revetment, to stabilize the toe of the slope and provide fish and wildlife habitat functions
- 3) removing non-native vegetation around the periphery (blackberries) not eliminated by grading
- 4) revegetating with native plant species

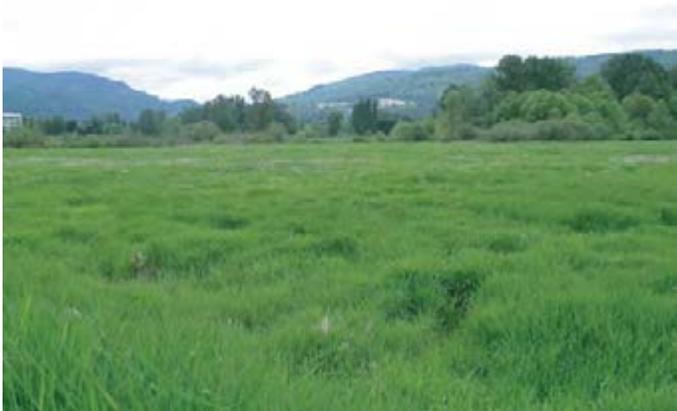
This large wetland, approximately 46 acres, is south of the boat launch between Lake Sammamish and East Lake Sammamish Parkway SE. The northern boundary of the wetland near the boat launch was delineated and identified as Wetland 4 in Wetlands Inventory for the Lake Sammamish State Park Property (The Coot Company, 2005). Dense, monotypic reed canarygrass dominates this abandoned hayfield and pasture. Blackberries are conspicuously absent from much of the area, as evidence of the wetter conditions found here compared to other wetlands in the park. Several ditches direct water westward into Lake Sammamish. There are small groves of trees and shrubs along the ditches, field edges, and scattered throughout the field.

Reed canarygrass dominates the existing open field

There is tremendous opportunity to greatly improve wetland functions and wildlife habitat, as well as aesthetics at this site. The ditches could be plugged and/or meander flow pathways created to increase hydrologic diversity. Topography could be changed to create wetland depressions throughout the field to further increase the complexity and edge character of the habitat while altering microclimates to discourage invasive plants. Installation

of snags, logs and brush piles, along with comprehensive and diverse revegetation would contribute to the overall restoration and value of this area. A trail and boardwalk loop connecting from the East Lake Sammamish Trail could allow for public access, viewing, and interpretive opportunities. This large project could be built in phases.

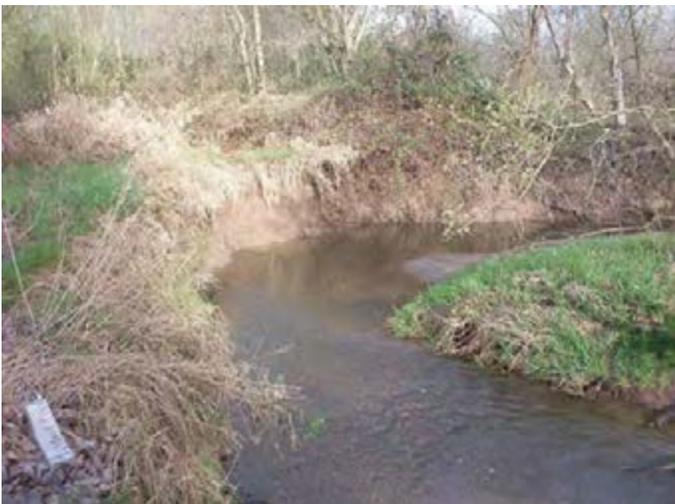
A previous stream restoration project along Tibbetts Creek was implemented by the Washington State Department of Transportation (WSDOT) along the park entrance road and extending westward from where the creek turns away from the road. The project provided floodplain widening along the left bank (facing downstream), in-stream log structure placement, streambed gravel placement, non-native vegetation removal, and revegetation with native plant species.

The existing Tibbetts Creek channel

This project would extend this same type of in-stream and riparian restoration farther downstream along Tibbetts Creek according to the same template. This extension of the previous project would similarly entail grading to extend the floodplain along the left bank, in-stream log structure placement, blackberry removal, and native revegetation downstream beginning where the previous WSDOT project left off. Furthermore, right bank work along this stream section would include removal of the obsolete silt fencing remaining from already-completed invasive plant removal and revegetation work.

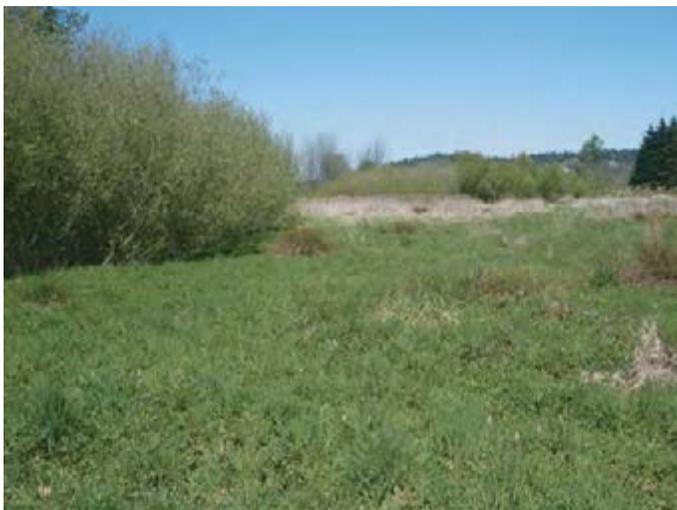
There is an approximately 15.5-acre wetland and upland field south of Issaquah Creek near the southeast center of the park. This area has more vegetative diversity than many of the other existing fields with large patches of willows, small-fruited bulrush, cattail, and horsetail. Willow and blackberry thickets edge the field. A ditch through this area directs water northward to Issaquah Creek. This wetland was not specifically delineated in the Wetlands Inventory for the Lake Sammamish State Park Property (The Coot Company, 2005), but it is connected to areas identified as Wetlands 6A and 6B. This report also indicates that this ditch receives significant input from stormwater runoff from the City of Issaquah. Drier, upland conditions are present in the north end of this field closer to Issaquah Creek. This area was generally described and identified in the Wetland Inventory report as Issaquah Creek Uplands, a “combination of slightly higher ground built up from flood overflow deposition plus the drainage effects from the creek channel ‘zone of influence’ which has created mostly linear ‘islands’ of upland ground along both sides of the creek.”

Fairly diverse existing vegetation

enhanced to increase habitat, food and cover values. The ditch could be plugged to increase wetland hydrology and accommodate more diverse plant communities. Logs and brush piles could be installed to provide additional habitat features. Upland plant communities could be planted to the north to create an overall complex of wetland and upland types.
