Washington State Parks and  
Recreation Commission  
**KOPACHUCK STATE PARK**

# Master Plan Report

June 27, 2014

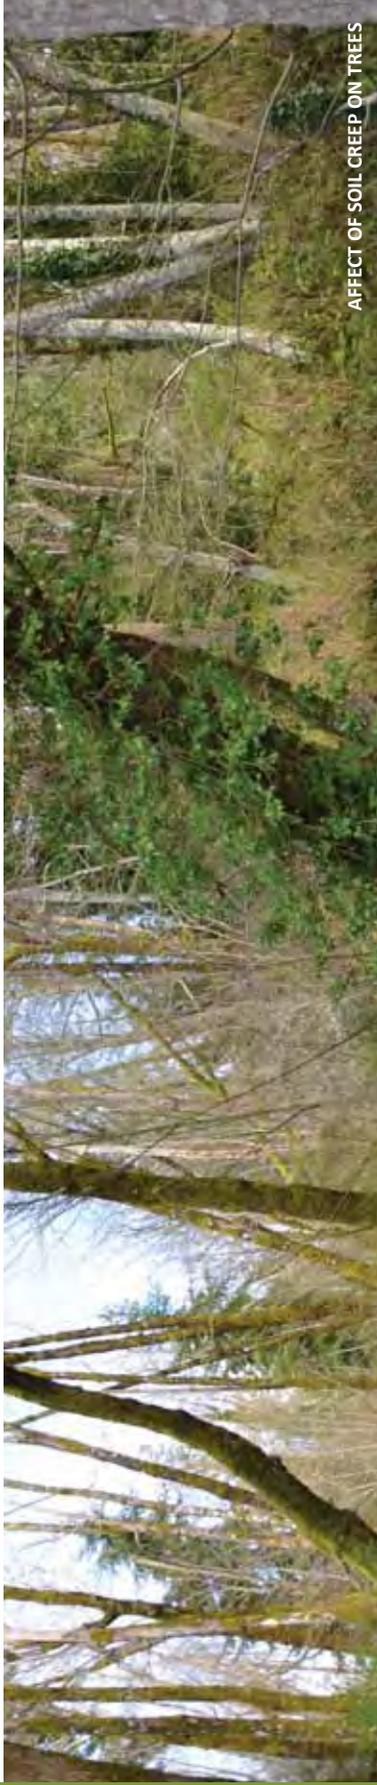
AFFECT OF SOIL CREEP ON TREES

The upland portion of the property is generally flat-lying with gently undulating terrain in places, vegetated primarily with native understory, deciduous trees, and evergreen trees. The upland portion of the park is made up primarily of evergreen trees standing upright, including trees up to 6' in diameter. Vertically oriented evergreen trees, some up to 3' in diameter, growing along the head scarp suggest relative stability along the scarp face. Trees just over the edge, however, have a pistol-butted growth pattern, suggesting ongoing localized soil creep.

The land below the head scarp consists of hummocky terrain – sloping relatively gently with native vegetation and a few trees (primarily alders) indicative of former landslide deposits below the head scarp. Many trees in this area, some as large as 3' in diameter, grow in a bending or twisting fashion. Coupled with the size of the trees, this growth pattern suggests

ongoing soil creep but no recent, large-scale movement within the area below the head scarp. A roughly 2' to 6' high bank leads down to the beach itself. Ongoing sloughing is affecting trees along the top of the bank. These trees are now leaning out toward the beach. There is dense glacial sediment extending through the beach gravel in places, suggestive of a “toe bulge,” possibly related to a former landslide.
