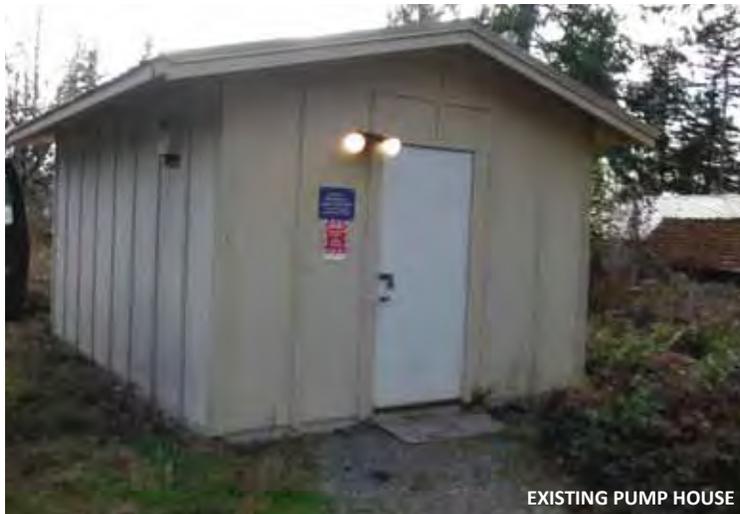
EXISTING PUMP HOUSE

The park receives domestic water supply from a single water well (constructed in 1980) located on state park property near the southwest corner of 56th Street NW and Kopachuck Drive NW. This system is a shared source facility that serves the park as well as Kopachuck Middle School and Voyager Elementary School (Peninsula School District). This system includes the well, a treatment facility, a distribution system, and a 40,000 gallon storage facility. There is an additional 70,000 gallon offsite fire flow storage and booster pump facility on school district property but this is for school protection only. The shared water system is managed by Peninsula Light Company which operates other small systems as well. The park is served by a 6" line from the storage tank which splits to serve the schools.

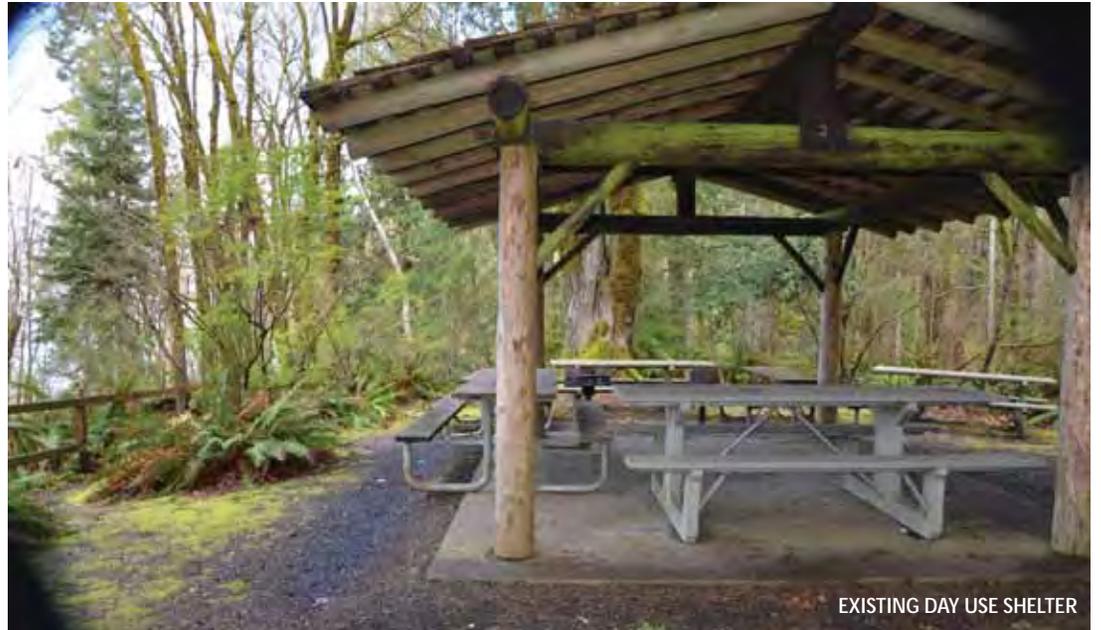
EXISTING DAY USE SHELTER

There are four open-sided, wood picnic shelters (approximately 10' x 20'). With their pole supports and shingle roofs, these structures are the appropriate character and scale for Kopachuck State Park. They should be relocated, if practical, within the site. The structures are currently located at the day use area adjacent to the top of the slope, the beach area, the Cascadia Marine Trail campsite, and the former group campsite.

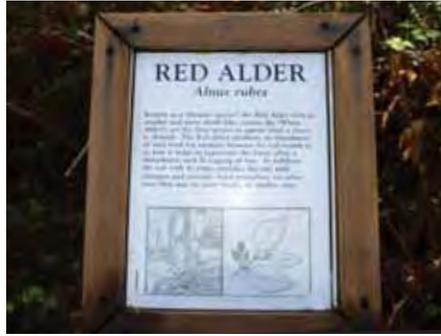
INTERPRETIVE LOOP

Portions of this trail cross wetland areas. Recent improvements have included grated fiberglass decking which provides stable, dry access while allowing wetland vegetation to flourish. In some areas, log rounds covered with asphalt shingles have been placed as non-slippery stepping blocks. Other sections of the trail are steep and dry. There are several plant identification signs placed around the trail as part of an Eagle Scout project. There is a wood kiosk at the northeast corner of the trail in a roadside area frequently used for parking by trail visitors. It has a sign explaining laminated root rot.

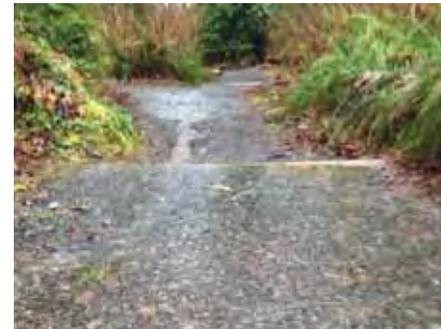
BEACH LOOP

The beach loop trail provides access from the day use parking lot and picnic area directly to the beach. Virtually all of the soil is poor draining and subject to erosion. Over the years, attempts to arrest the erosion and provide access in steep areas have resulted in a variety of materials and solutions throughout the length of the trail. A small bridge has an unsafe base and portions of the trail close to the beach are constantly shifting. Social trails that have evolved pose risks to visitors because of their precarious locations and conditions resulting from lack of maintenance.
